***Federal Railroad Administration
Office of Railroad Safety
Accident and Analysis Branch***

***Accident Investigation Report
HQ-2018-1288***

***CSX Transportation (CSX) Highway-Rail Grade Crossing Accident
College Park, Georgia
July 30, 2018***

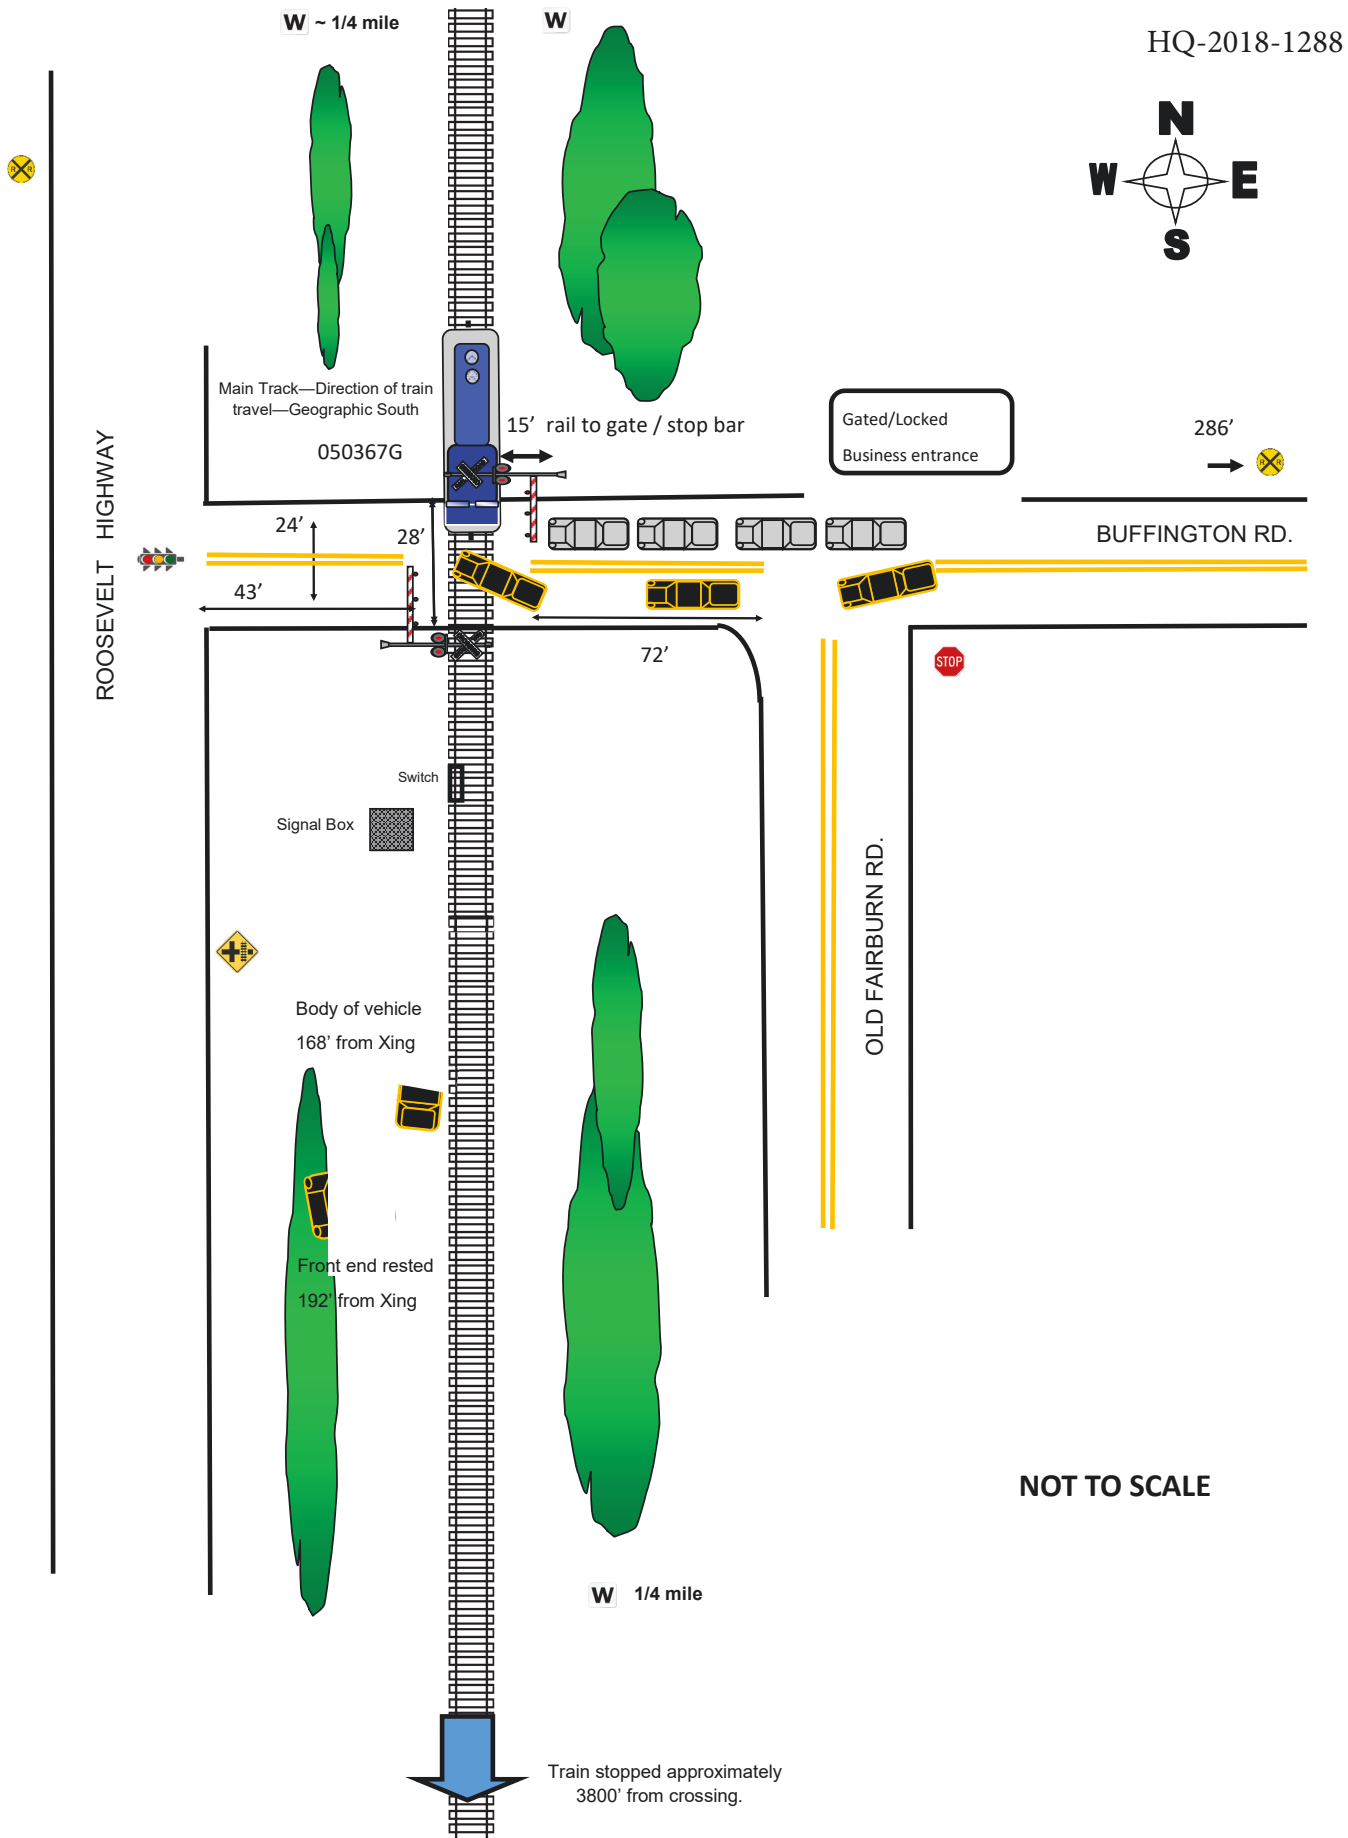
Sketch - Sketch of Accident

At about 4:10 p.m., EST, Train 1 was entering the crossing at Buffington Road, traveling 38 mph on a clear signal indication and sounding the horn, when the Engineer observed Vehicle 1 drive around stopped traffic, and the lowered warning gates, and enter the crossing ahead of the train. Train 1 struck Vehicle 1 on the passenger side of the vehicle resulting in the separation of the front end of the vehicle from the passenger compartment. The front end of Vehicle 1 came to rest 192-feet from the point of impact (POI) at Buffington Road, and the passenger compartment was 168-feet from the POI, and about 20-feet from the west rail.
